# Site Accessibility Evaluation

### **Bijou Parking Garage (Enterprise)**

**Accessibility Evaluation**

***Inspection Date: 07/09/2018  
Inspector: Michael Killebrew, Anna  
Kangas***

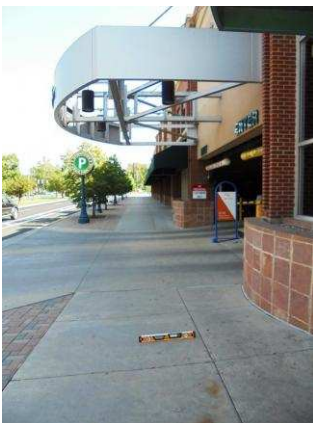
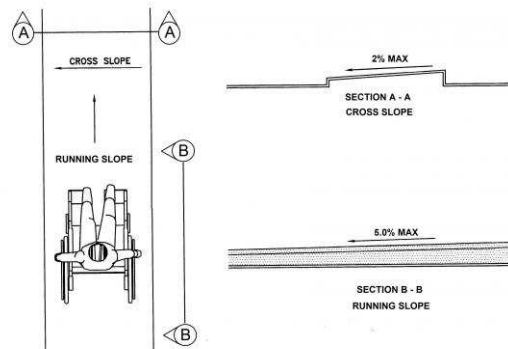
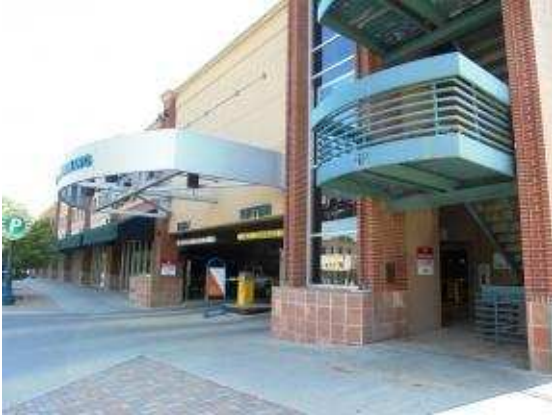
**Finding #1 Additional Finding Photos**

The accessible route contains running slopes greater than 5 percent and cross slopes greater than 2 percent.

Near the main entrance to the garage is a section of sidewalk with up to 5.5% cross slope and up to 4% running slope.

The running slope can match road grade, but the cross slope should not exceed 2%. Remove and replace this section of sidewalk.

1 (High): Should be completed immediately. (Includes findings that have little or no cost, were in violation of the codes at the time of construction, or pose an imminent safety threat)

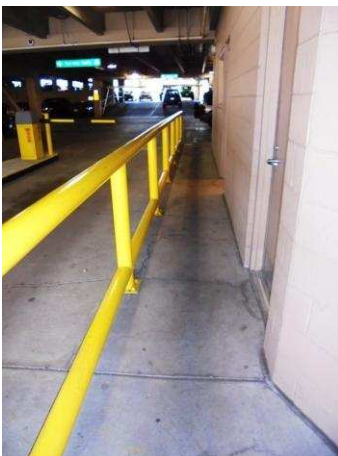
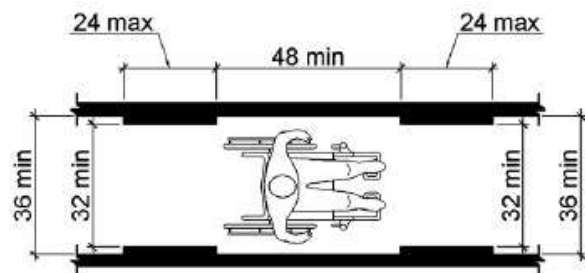
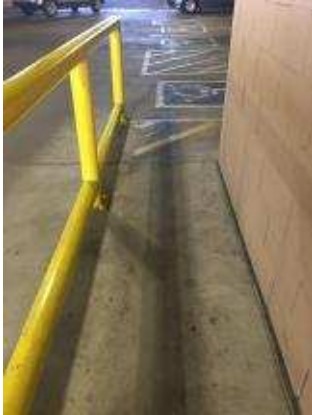
Finding 185935 Main Photo

The route of travel at this location does not provide a minimum width of 36 inches. The space between the wall and barrier is 36", but the base plates of the barrier reduce the width to 34" or less.

The route between the office wall and the barrier fence is not wide enough.

Consider moving the barrier 2" farther toward the drive aisle, or redesign the base plates so they do not interfere with the clear width.

1 (High): Should be completed immediately. (Includes findings that have little or no cost, were in violation of the codes at the time of construction, or pose an imminent safety threat)

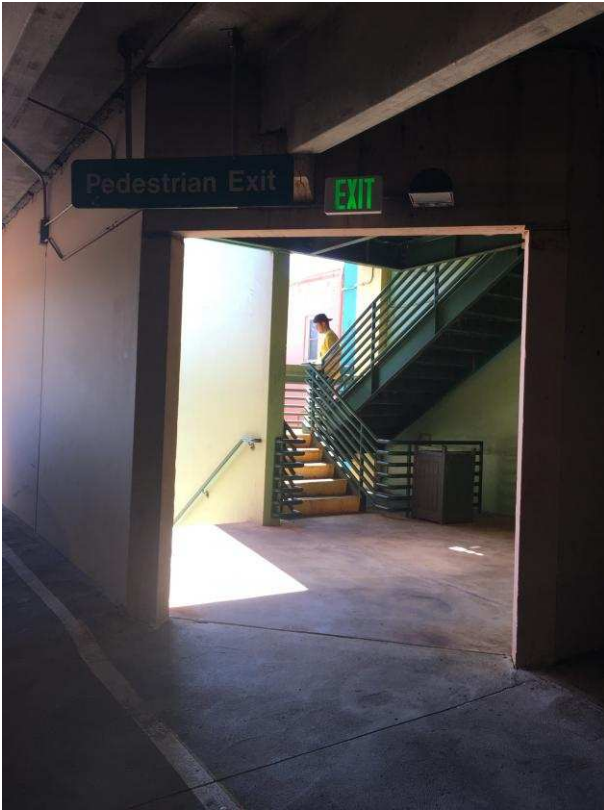
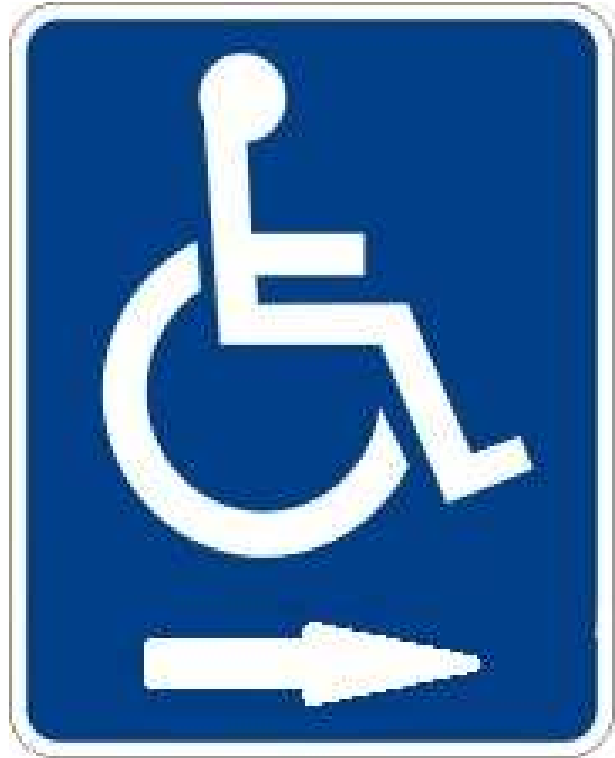
**Finding #3 Continued**

The entrance is not accessible and is missing signage. An identification sign identifying that this entrance is not accessible and directional signage pointing in the direction to the accessible entrance is required.

**There is not signage at the southeast entrance indicating it is not accessible.**

**Install a sign indicating the location of the accessible exits. It may be wise to install several signs near the accessible parking to reduce backtracking.**

**3 (Moderate): Should be completed as soon as possible, but there may be other items that will provide greater access to persons with disabilities. (Includes findings that have a high financial impact on the entity in relationship to the degree of access provided)**

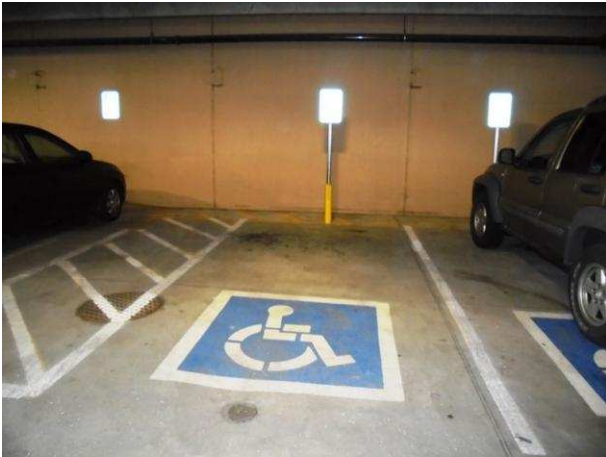
**Finding #4 Continued**

**The required number of van accessible stalls is not provided.**

**Only one space is indicated as van accessible.**

**Designate an additional space as van accessible.**

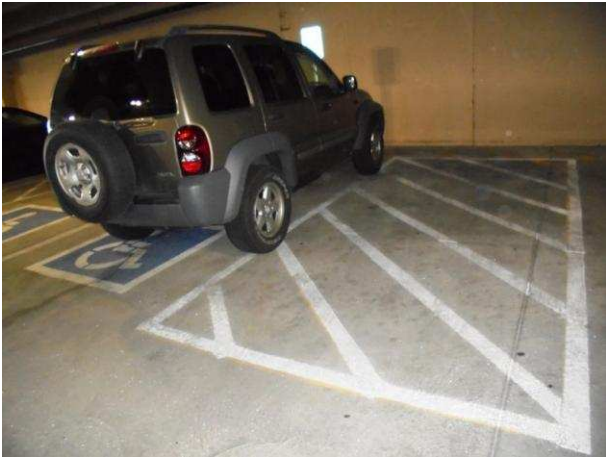
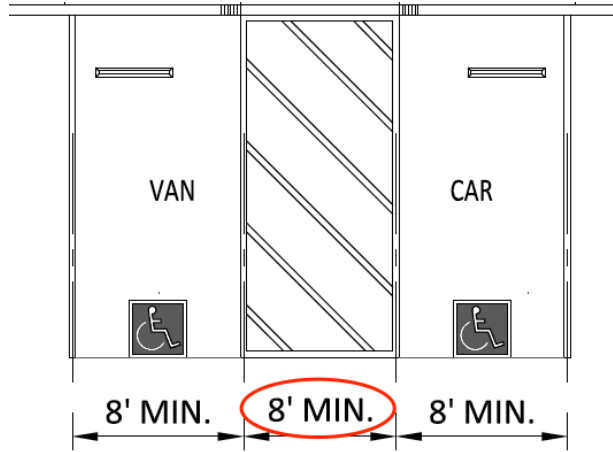
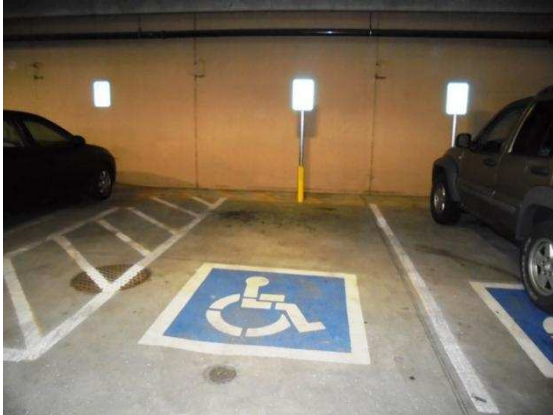
**Finding #5 Continued**

The access aisle is not a minimum 8 feet to the centerline of the stripe.

The access aisle for the van accessible spaces is only 7'-9" wide.

Restripe the aisle to 8'-0" wide.

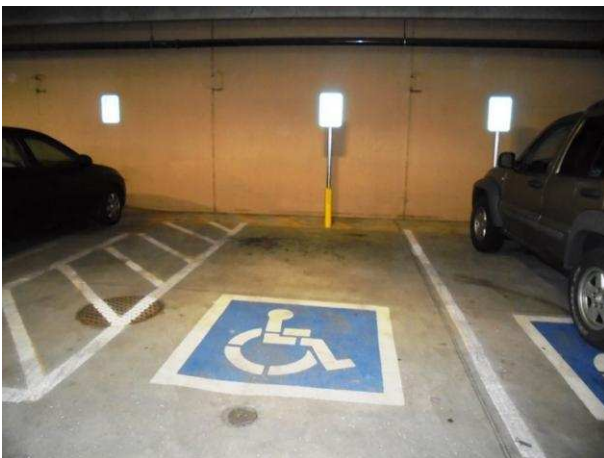
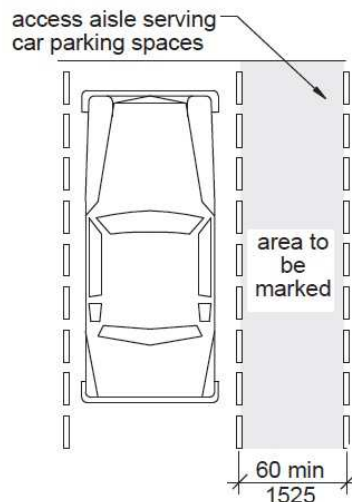
The access aisle is not a minimum 5 feet wide.

The access aisle for the car accessible spaces is 4'-9" wide.

Restripe the access aisle to 5'-0" wide.

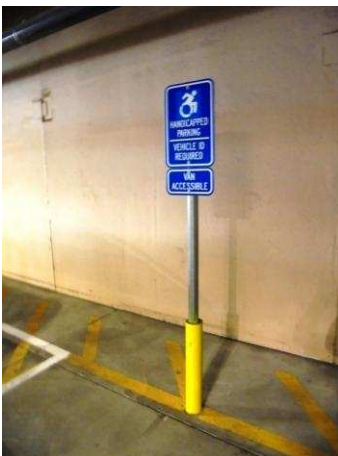
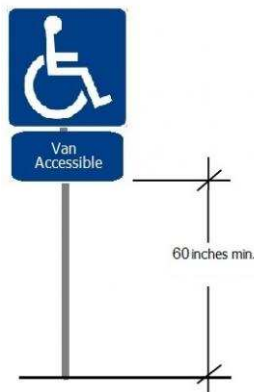
The parking sign is mounted too low.

The van accessible signage is mounted at 54-1/2" to the bottom of the sign.

Increase the height of the sign to 60" to the bottom.

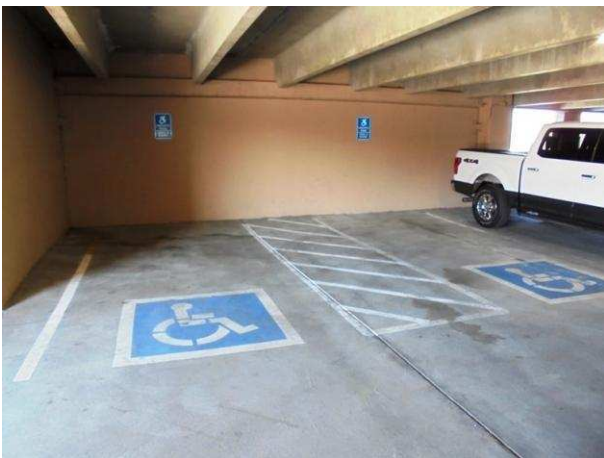
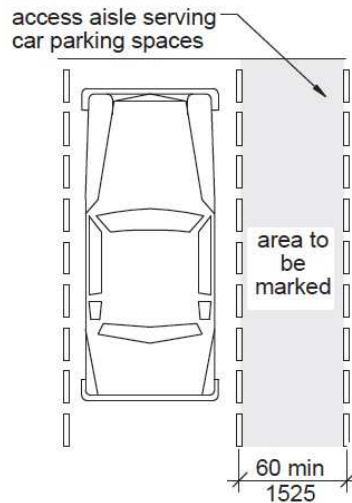
The access aisle is not a minimum 5 feet wide. The adjacent parking space is 8'-4", so there is adequate width to provide a compliant access aisle.

The access aisle is 4'-8" wide.

Restripe to provide a 5'-0" wide access aisle.

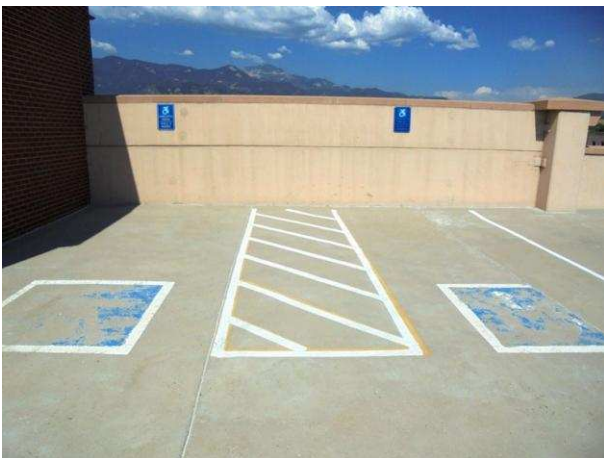
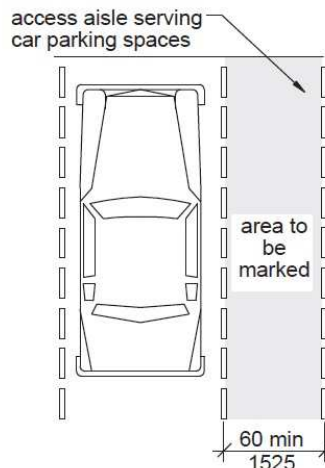
The access aisle is not a minimum 5 feet wide. The accessible space on the left is 9'-10" wide, and the space on the right is 8'-5", so there is adequate space to provide compliant access aisle and parking spaces.

The access aisle is only 4'-7" wide.

Restripe to provide a 5'-0" wide access aisle.

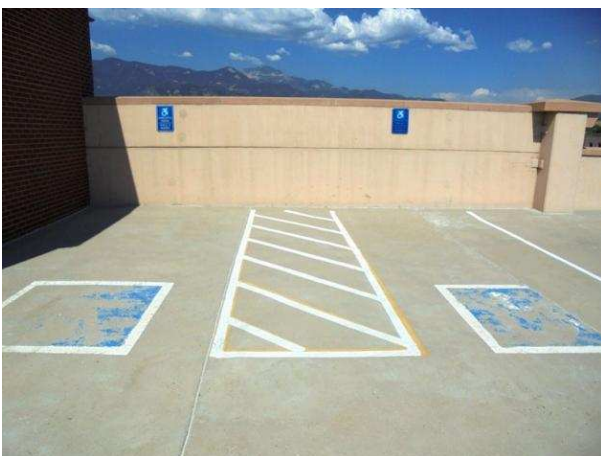
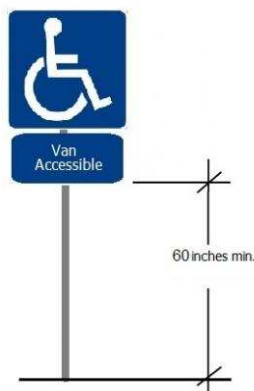
The parking sign is mounted too low.

The accessible parking signage is mounted at 52-1/2" to the bottom edge.

Increase the height of the signs to 60" to the bottom of the signs.

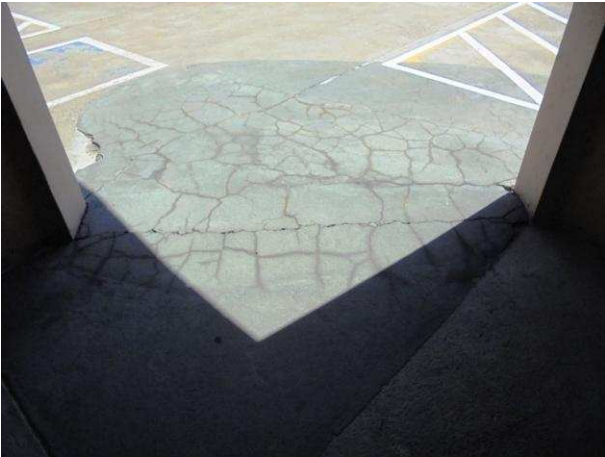
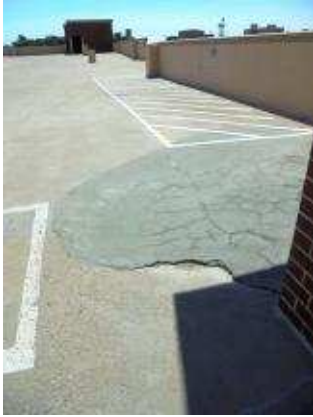
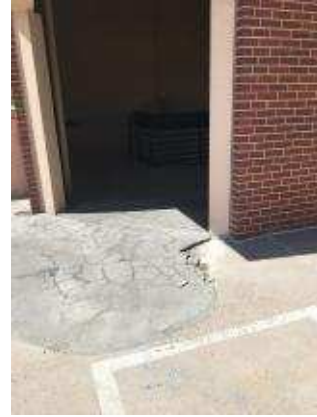
**Finding #12 Continued**

The walkway contains abrupt vertical edges and/or variations over a 1/4 inch.

The concrete at the entrance to the elevator is failing.

This facility was revisited in June 2019 and the concrete topping has deteriorated further.

Remove and replace the topping.
