# Site Accessibility Evaluation

### Downtown Bus Terminal

Accessibility Evaluation

SUBJECT: Downtown Bus Terminal Self-Evaluation

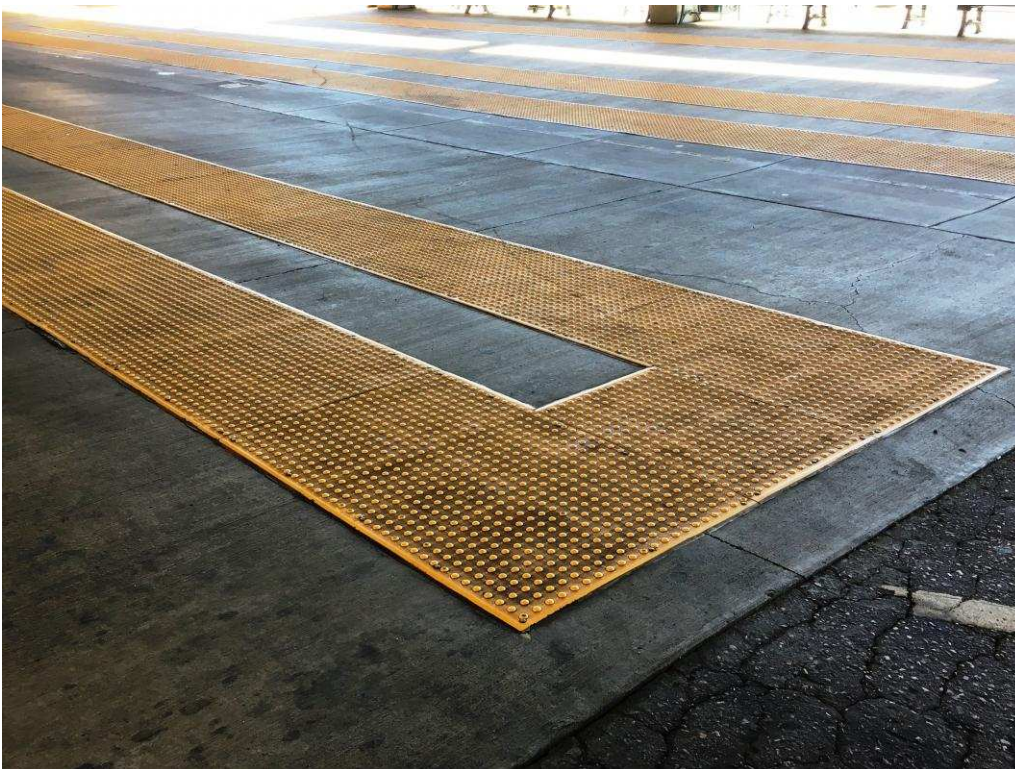
**Finding: 1**

The domes are springy and are not firm. It may be due to the adhesive used.

The domes at the loading area are not firm and are not installed in the appropriate manner.

Image of noncompliant dome pathway

Remove and replace the domes so they are firm, limiting their use.

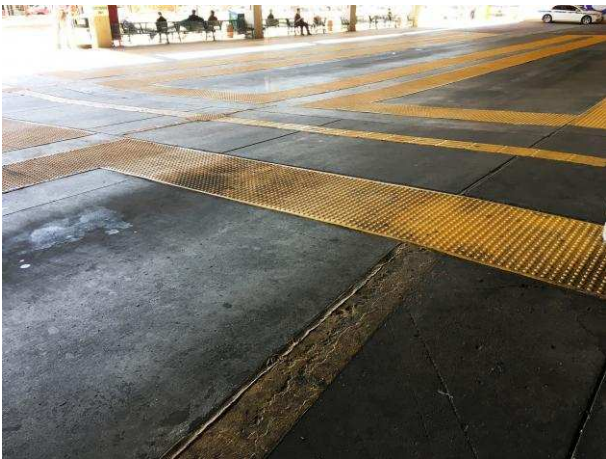
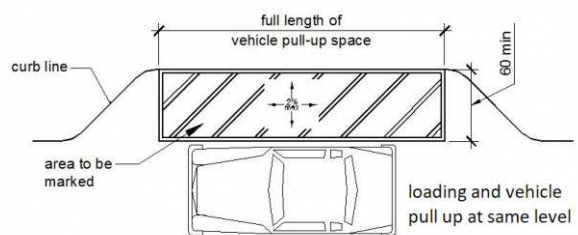
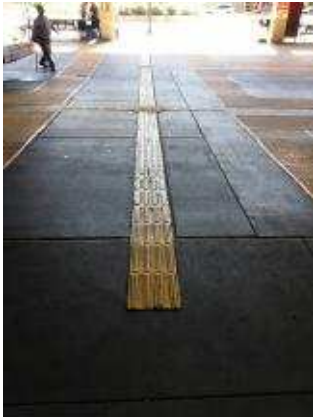
### Finding: 2

The east loading areas are acceptable.

The middle loading area has cross slopes from 3% to 4.5%.

The west loading area has cross slopes from 4% to 5.4%.

The loading zones have excessive slopes (over 2%).

Image of bus loading zones

**Additional image of bus loading zones**

Remove and replace paving to provide maximum 2% cross slopes at the loading areas.

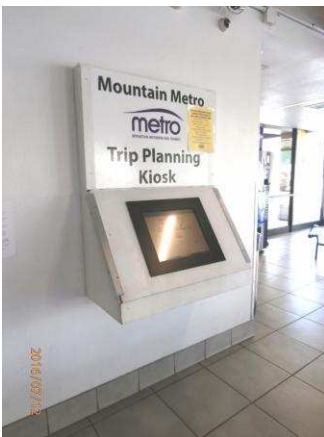
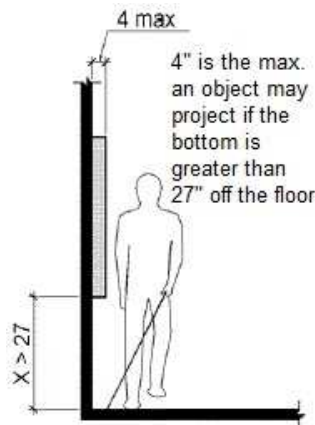
**Finding: 3**

The trip kiosk projects more than 4 inches into the circulation path.

The trip kiosk protrudes 18" from the wall and the bottom edge is 29-1/4" above the floor.

Image of trip kiosk projecting into path

Lower the kiosk 2-1/4" so the bottom edge is at 27" maximum. Or install a cane detection panel that projects 2-1/4" below the bottom edge. If the kiosk is lowered, ensure it is mounted with exactly 27" knee clearance.

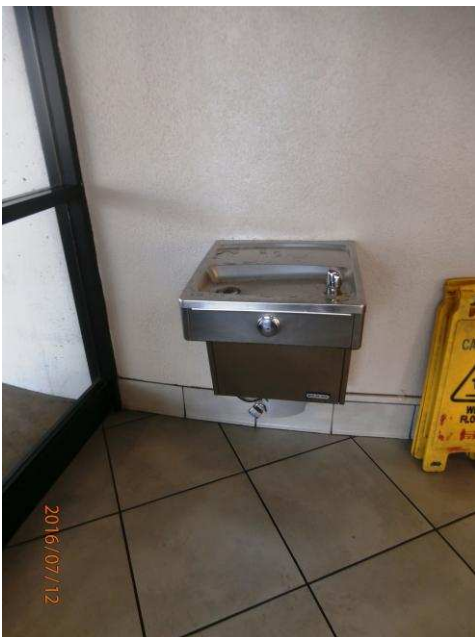
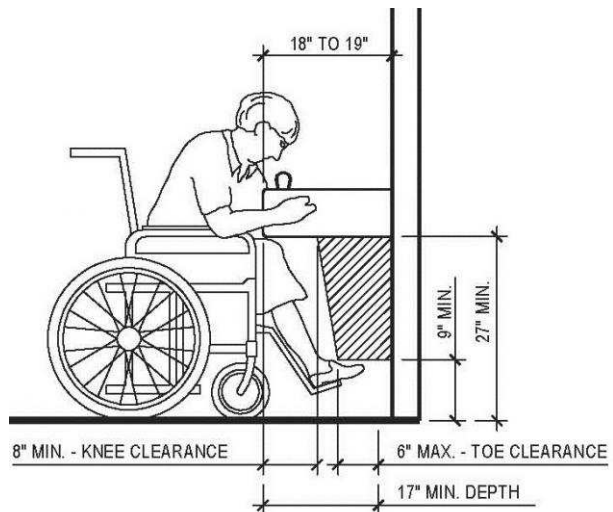
**Finding: 4**

There is not enough knee clearance under the drinking fountain.

There is only 25" of knee clearance at the water fountain.

Image of noncompliant drinking fountain

Raise the fountain by 2".

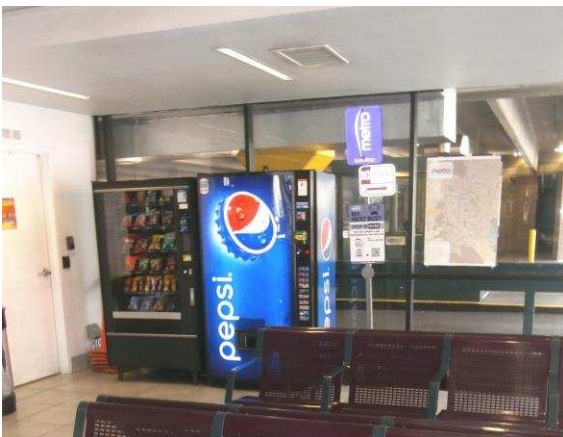
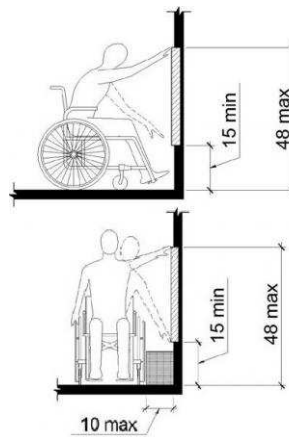
**Finding: 5**

On the snack vending machine, the card reader is mounted at 58". On the soda machine, the card reader is mounted at 53-1/2".

The payment options are mounted too high on the vending machines.

Image of inaccessible vending machines

Work with the vendor to install compliant machine doors so that the operable controls are within reach range..

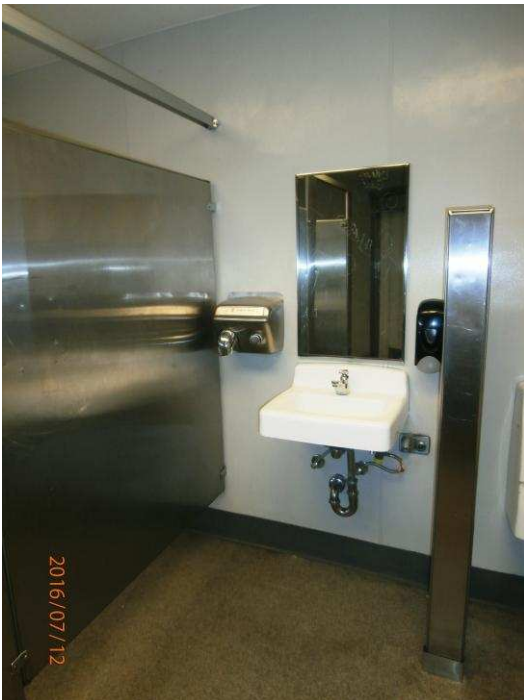
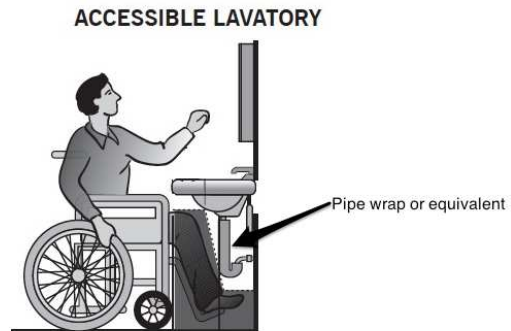
**Finding: 6**

The water and drain pipes under the lavatory are not adequately insulated.

The lavatory pipes do not have insulation.

Image of lavatory without pipe insulation

Insulate the pipes.

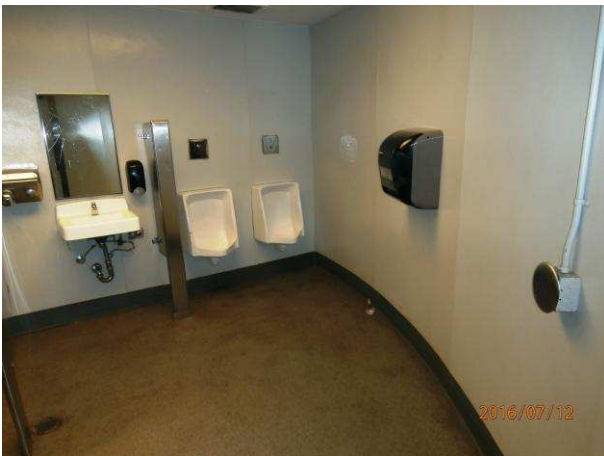
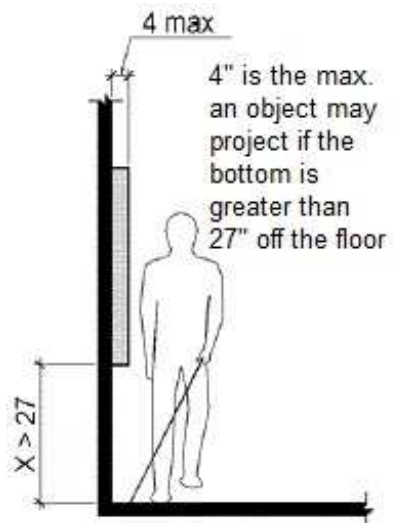
### Finding: 7

The manual paper towel dispenser projects more than 4 inches into the circulation path.

The manual paper towel dispenser protrudes 9-1/2" from the wall.

Image of paper towel dispenser projecting into path

Relocate or remove the dispenser as there is not adequate cane protection from the dispenser.

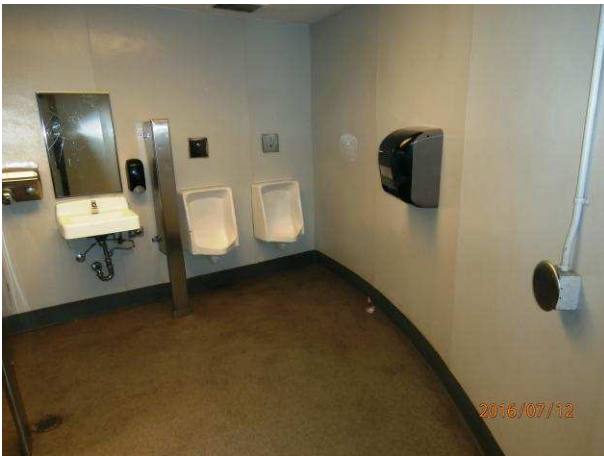
### Finding: 8

The paper towel dispenser's operation mechanism is too high off the floor.

The manual paper towel dispenser is mounted at 50-1/2" to the operable parts.

Image of paper towel dispenser mounted too high

When the paper towel dispenser is relocated, lower it to maximum 48" to the operable part.

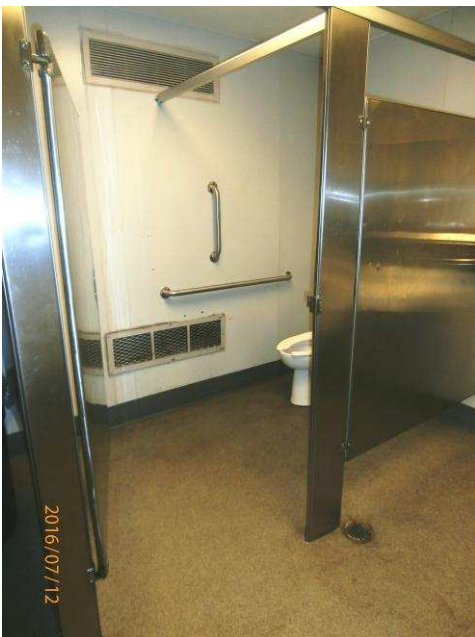
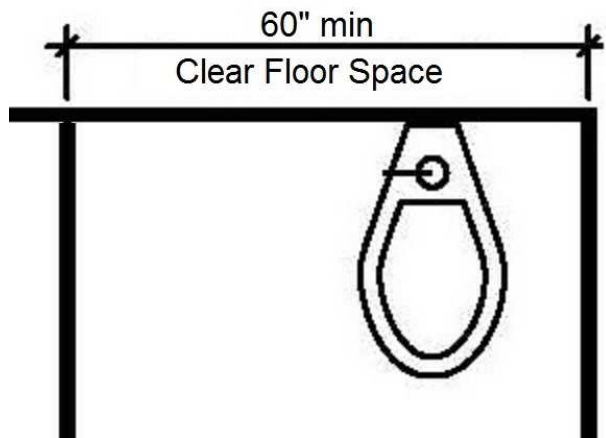
### Finding: 9

The toilet compartment is not wide enough.

The stall is 56" wide.

Image of narrow toilet stall

Reconfigure the restroom to provide a 60" wide stall.

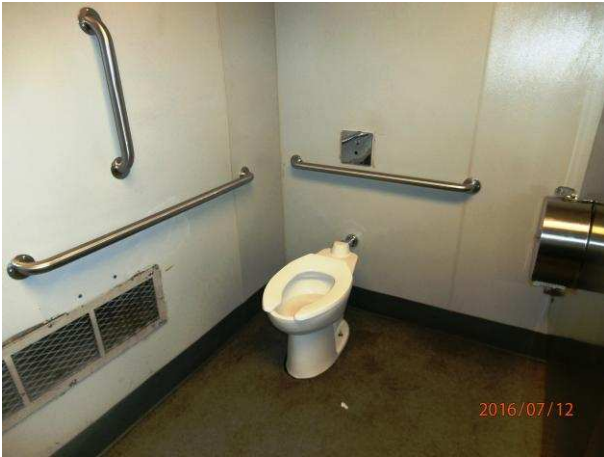
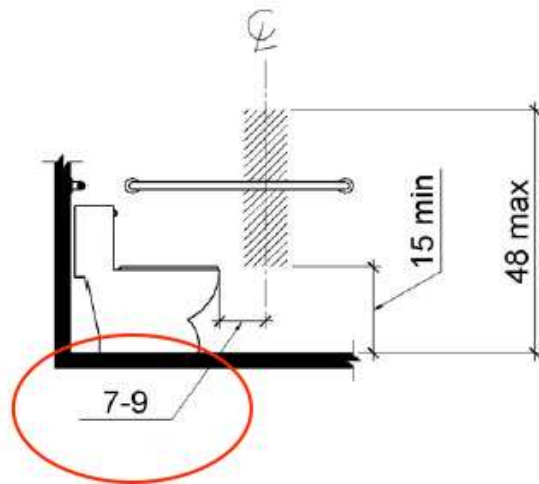
**Finding #10 Continued**

The toilet paper is not installed within the compliant range to the side of the toilet. The maximum side reach is 24".

The toilet paper is on the opposite wall from the grab bars, with a reach of 26".

Image of toilet paper installed too far from toilet

Relocate the toilet paper.

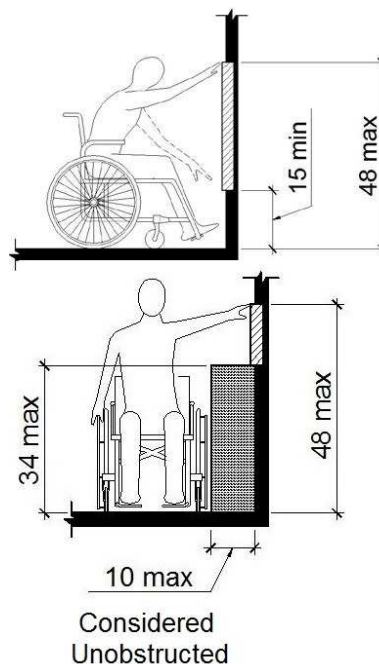
### Finding: 11

The coat hook is installed greater than 48 inches above the finished floor.

The coat hook is missing, but it was mounted at 64".

Install a coat hook at 48" maximum.

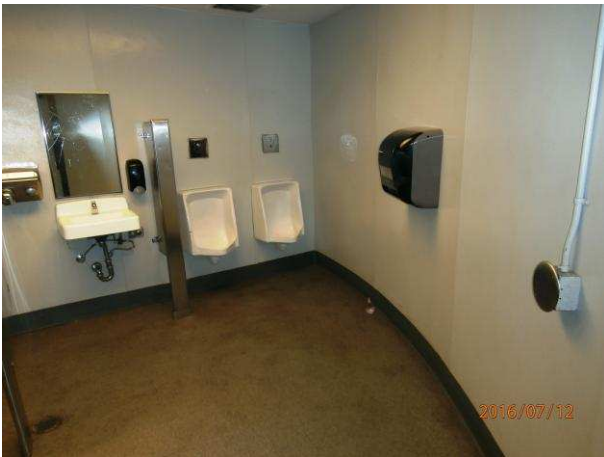
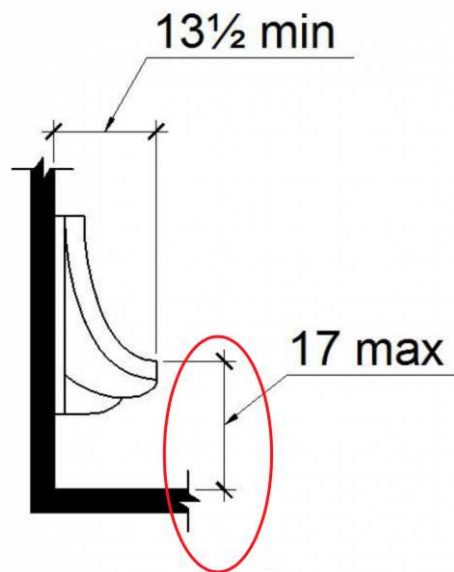
### Finding: 12

The rims of the urinals are too high.

The urinals are mounted at 18-1/4" to the rim.

Image of urinals mounted too high

Lower one of the urinals to 17" maximum to the rim.

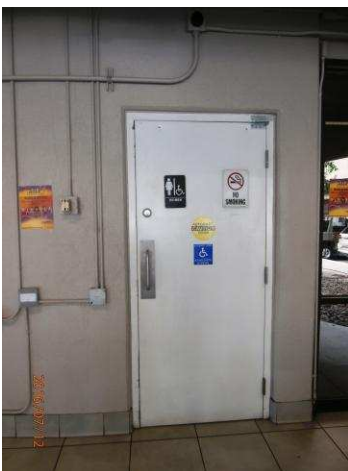
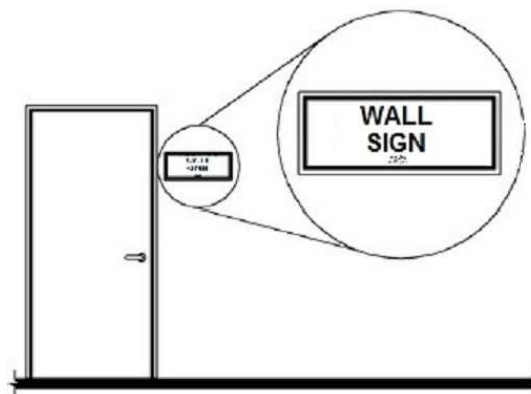
### **Finding: 13**

The tactile sign is incorrectly located.

The restroom sign is mounted on the pull side of door.

Image of noncompliant restroom signage

Move the sign to latch side of the door.

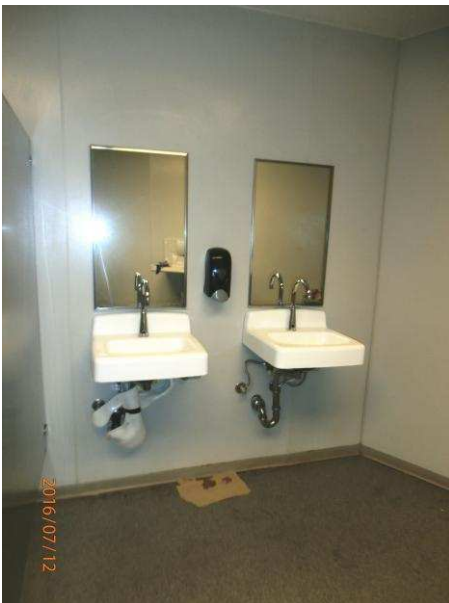
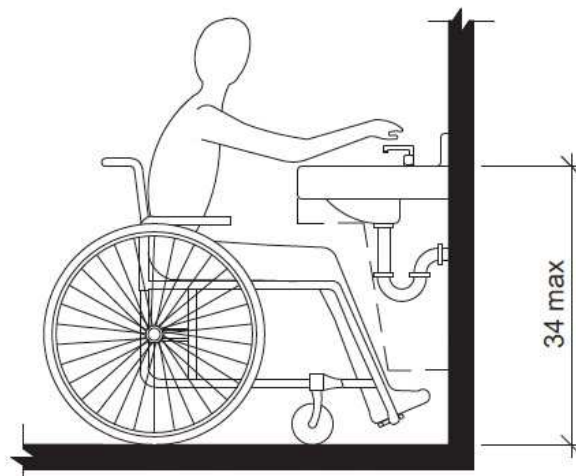
### Finding: 14

The top rim of the lavatory is too high.

Only one of the lavatories has insulated pipes.

The lavatory height is 34-1/2" to the rim.

Image of noncompliant lavatory

Lower the lavatory with insulated pipes to 34" maximum to the rim and then identify it as the accessible lavatory with an ISA sticker on the mirror.

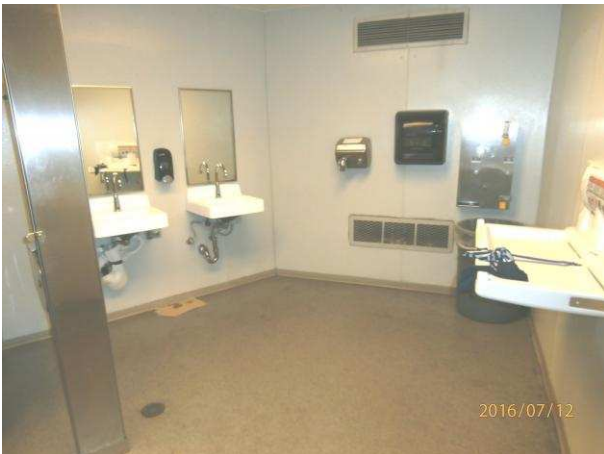
### Finding: 15

The paper towel dispenser's operation mechanism is too high off the floor. At the time of this evaluation, the automatic towel dispenser was inoperable.

The manual paper towel dispenser is mounted at 55-1/4".

Image of paper towel dispenser mounted too high

Lower the paper towel dispenser to 48" maximum.

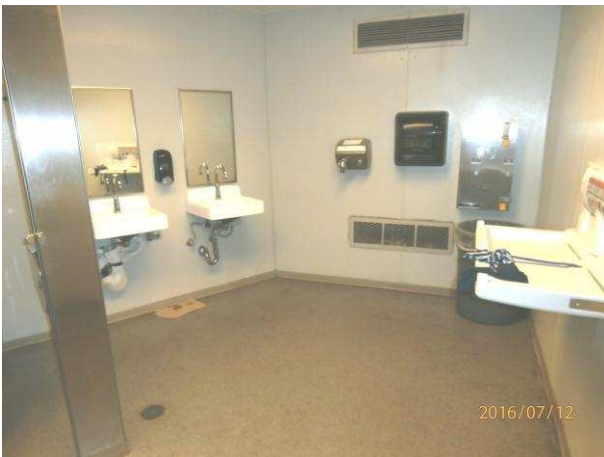
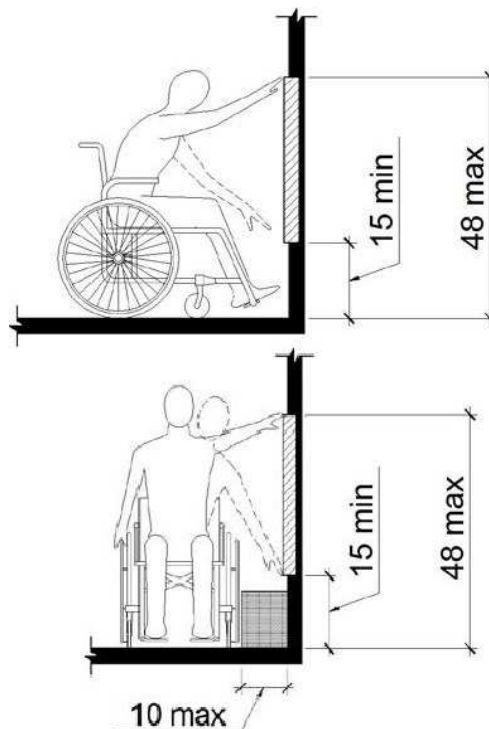
### Finding: 16

The work surface is required to be at 34" maximum.

The work surface of the baby changing table is 38".

Image of noncompliant diaper changing station

Lower the baby changing station, while providing at least 27" of knee clearance.

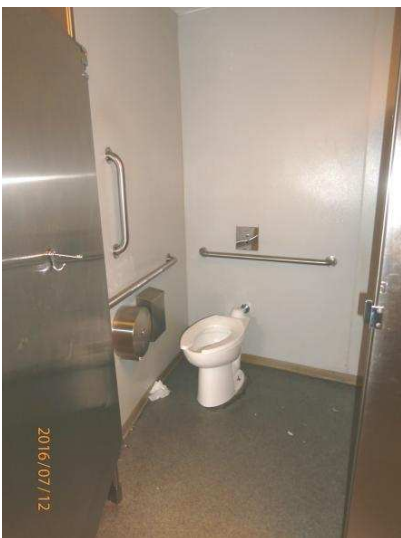
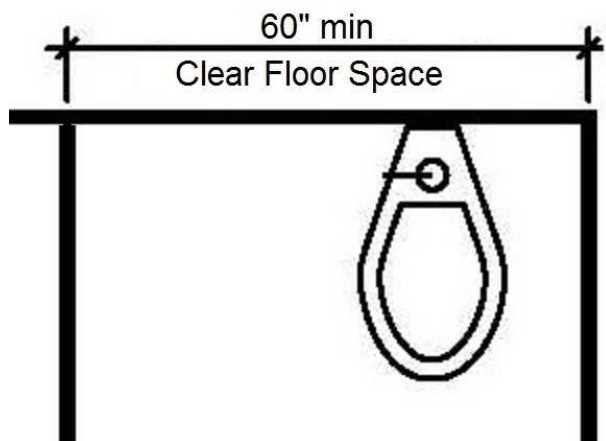
### Finding: 17

The toilet compartment is not wide enough.

The toilet compartment ranges in width from 45-1/2" to 54".

Image of narrow toilet stall

Reconfigure the restroom to provide a compliant width toilet stall.

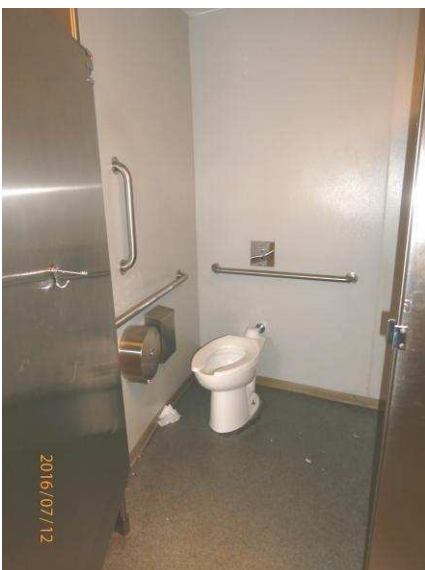
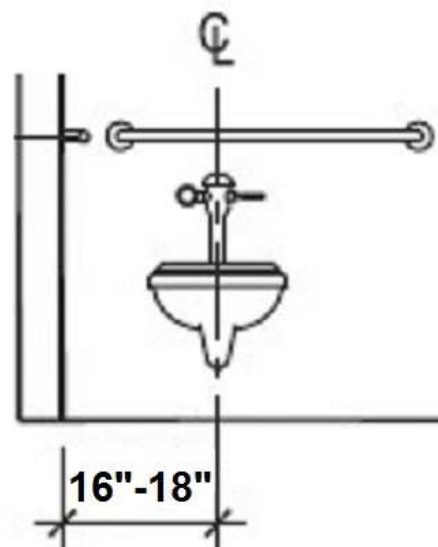
### Finding: 18

The toilet is not located within the range allowed from the side wall or partition, and it is angled to the wall.

The toilet is 13-1/2" from the wall to centerline of toilet.

Image of toilet too close to wall

Move the toilet and install it a consistent dimension from the wall.
