Renovation Specific Asbestos Survey Report

4331 Deerfield Hills Rd
Colorado Springs, CO 80916

Anderson Property Inspections
Colorado Springs, CO

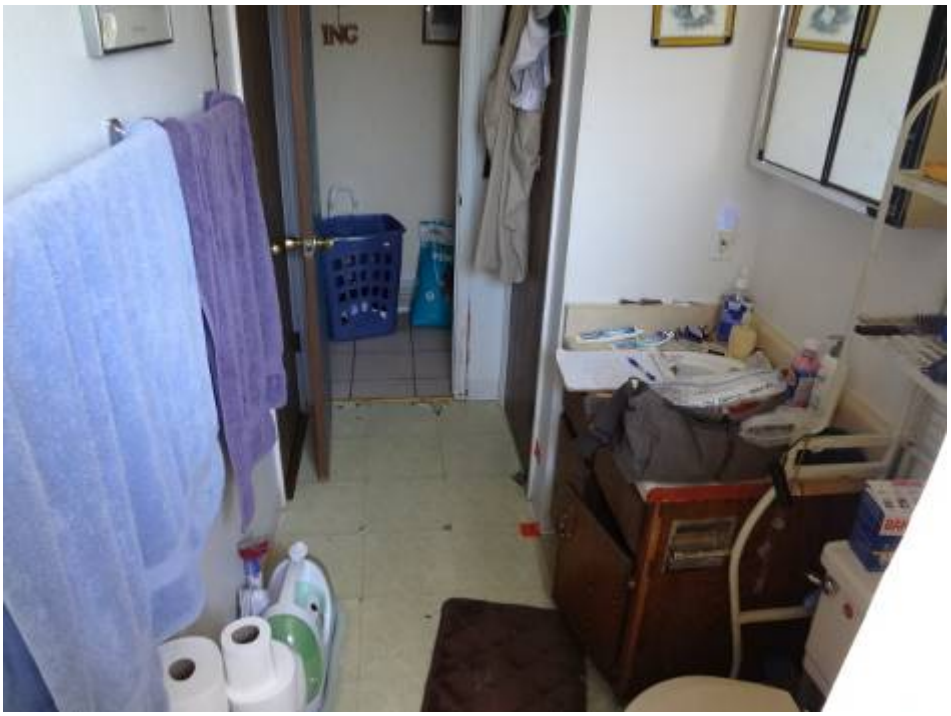
Bathroom overview all samples taken from this room are non-detect for asbestos

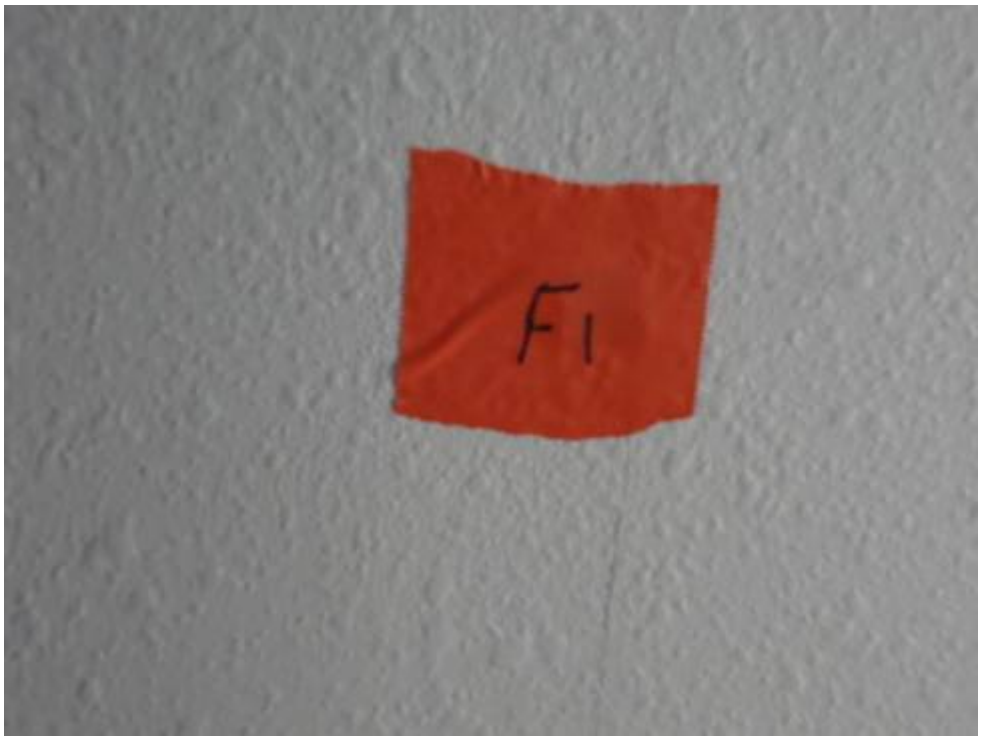
Tub surround sample tested non-detect for asbestos
