Site Accessibility Evaluation

CSPD Impound Lot

Accessibility Evaluation

Inspection Date: 08/01/2018
Inspector: Michael Killebrew

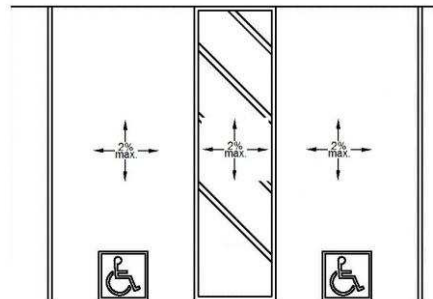
Finding #2 Additional Finding Photos

The cross slopes (narrow dimension) and/or running slopes (long dimension) of the accessible stall exceeds 2%.

40' long x 4' wide across the parking spaces and access aisles running slopes as high as 3%.

Correct the cross slope of the stalls to 2% or less.

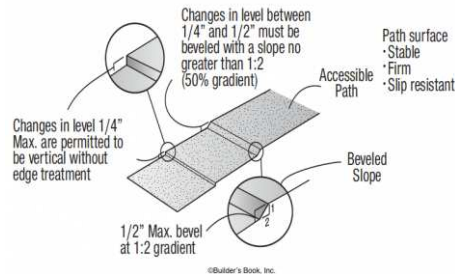
Finding #4 Additional Finding Photos

The accessible route contains loose gravel and/or surfaces that do not provide for a stable, firm slip resistant surface.
