# BRIDGE CONDITIONS & CONSTRUCTION CHALLENGES

## Existing Structure Safety

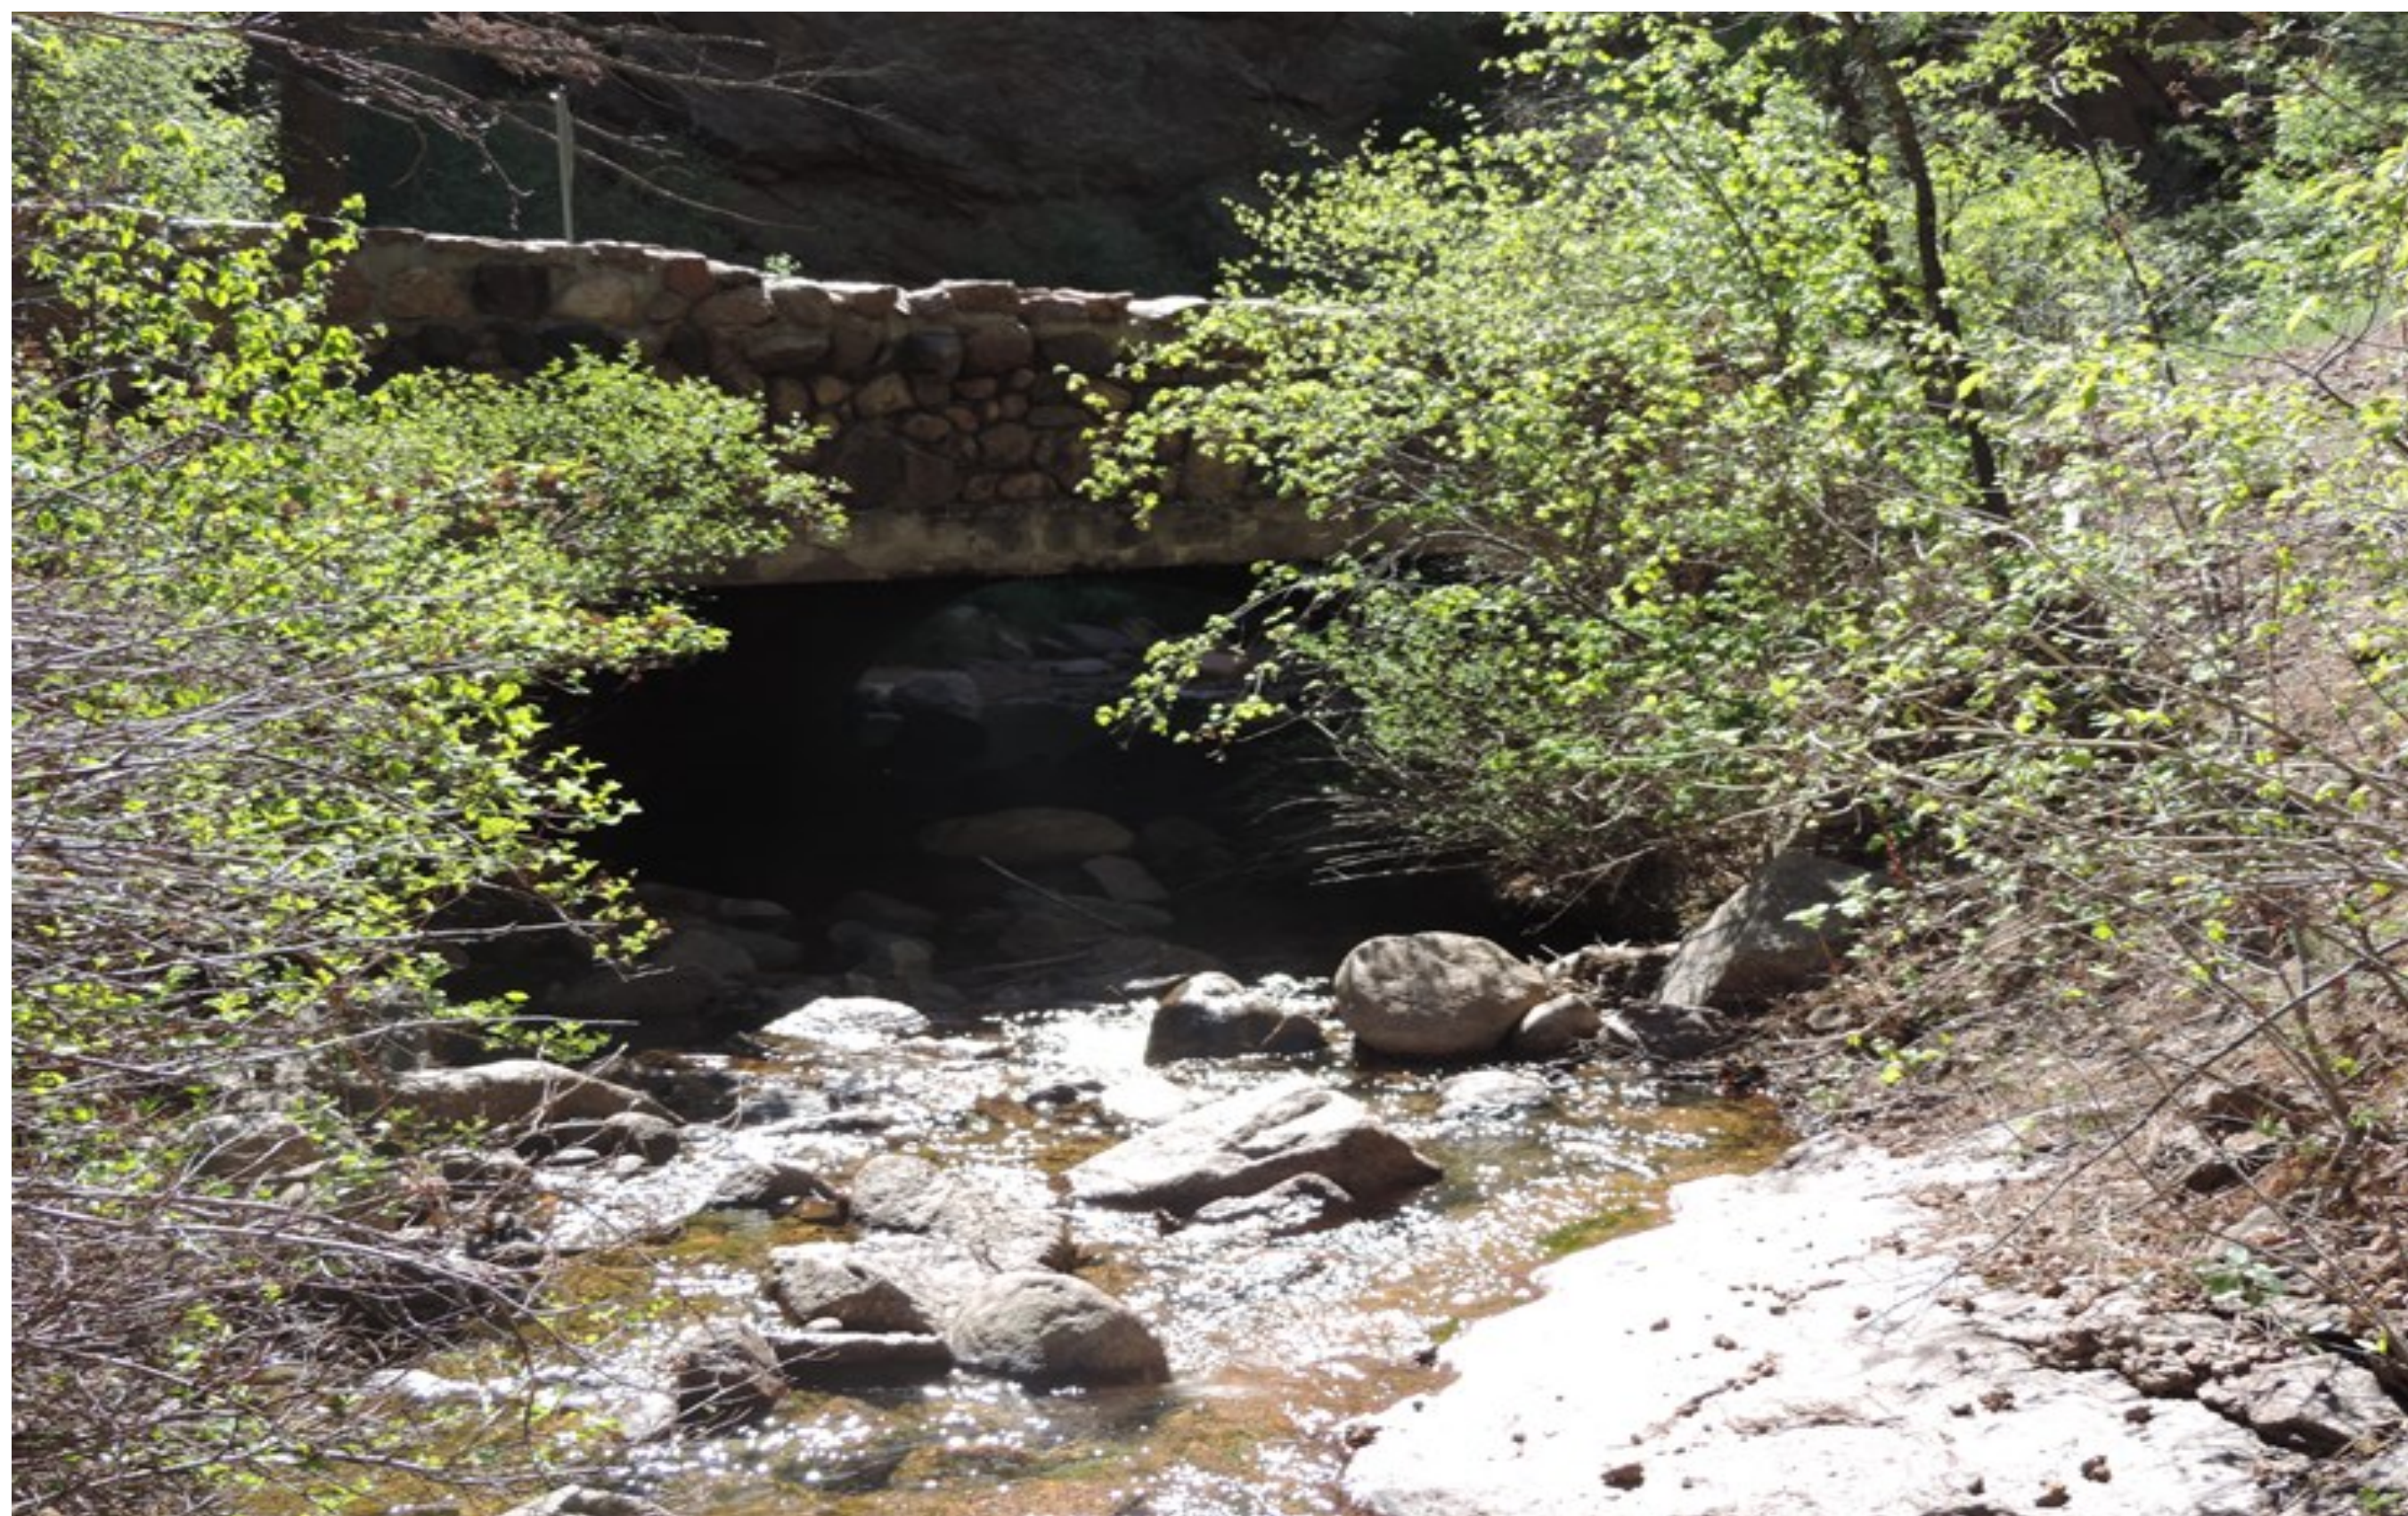
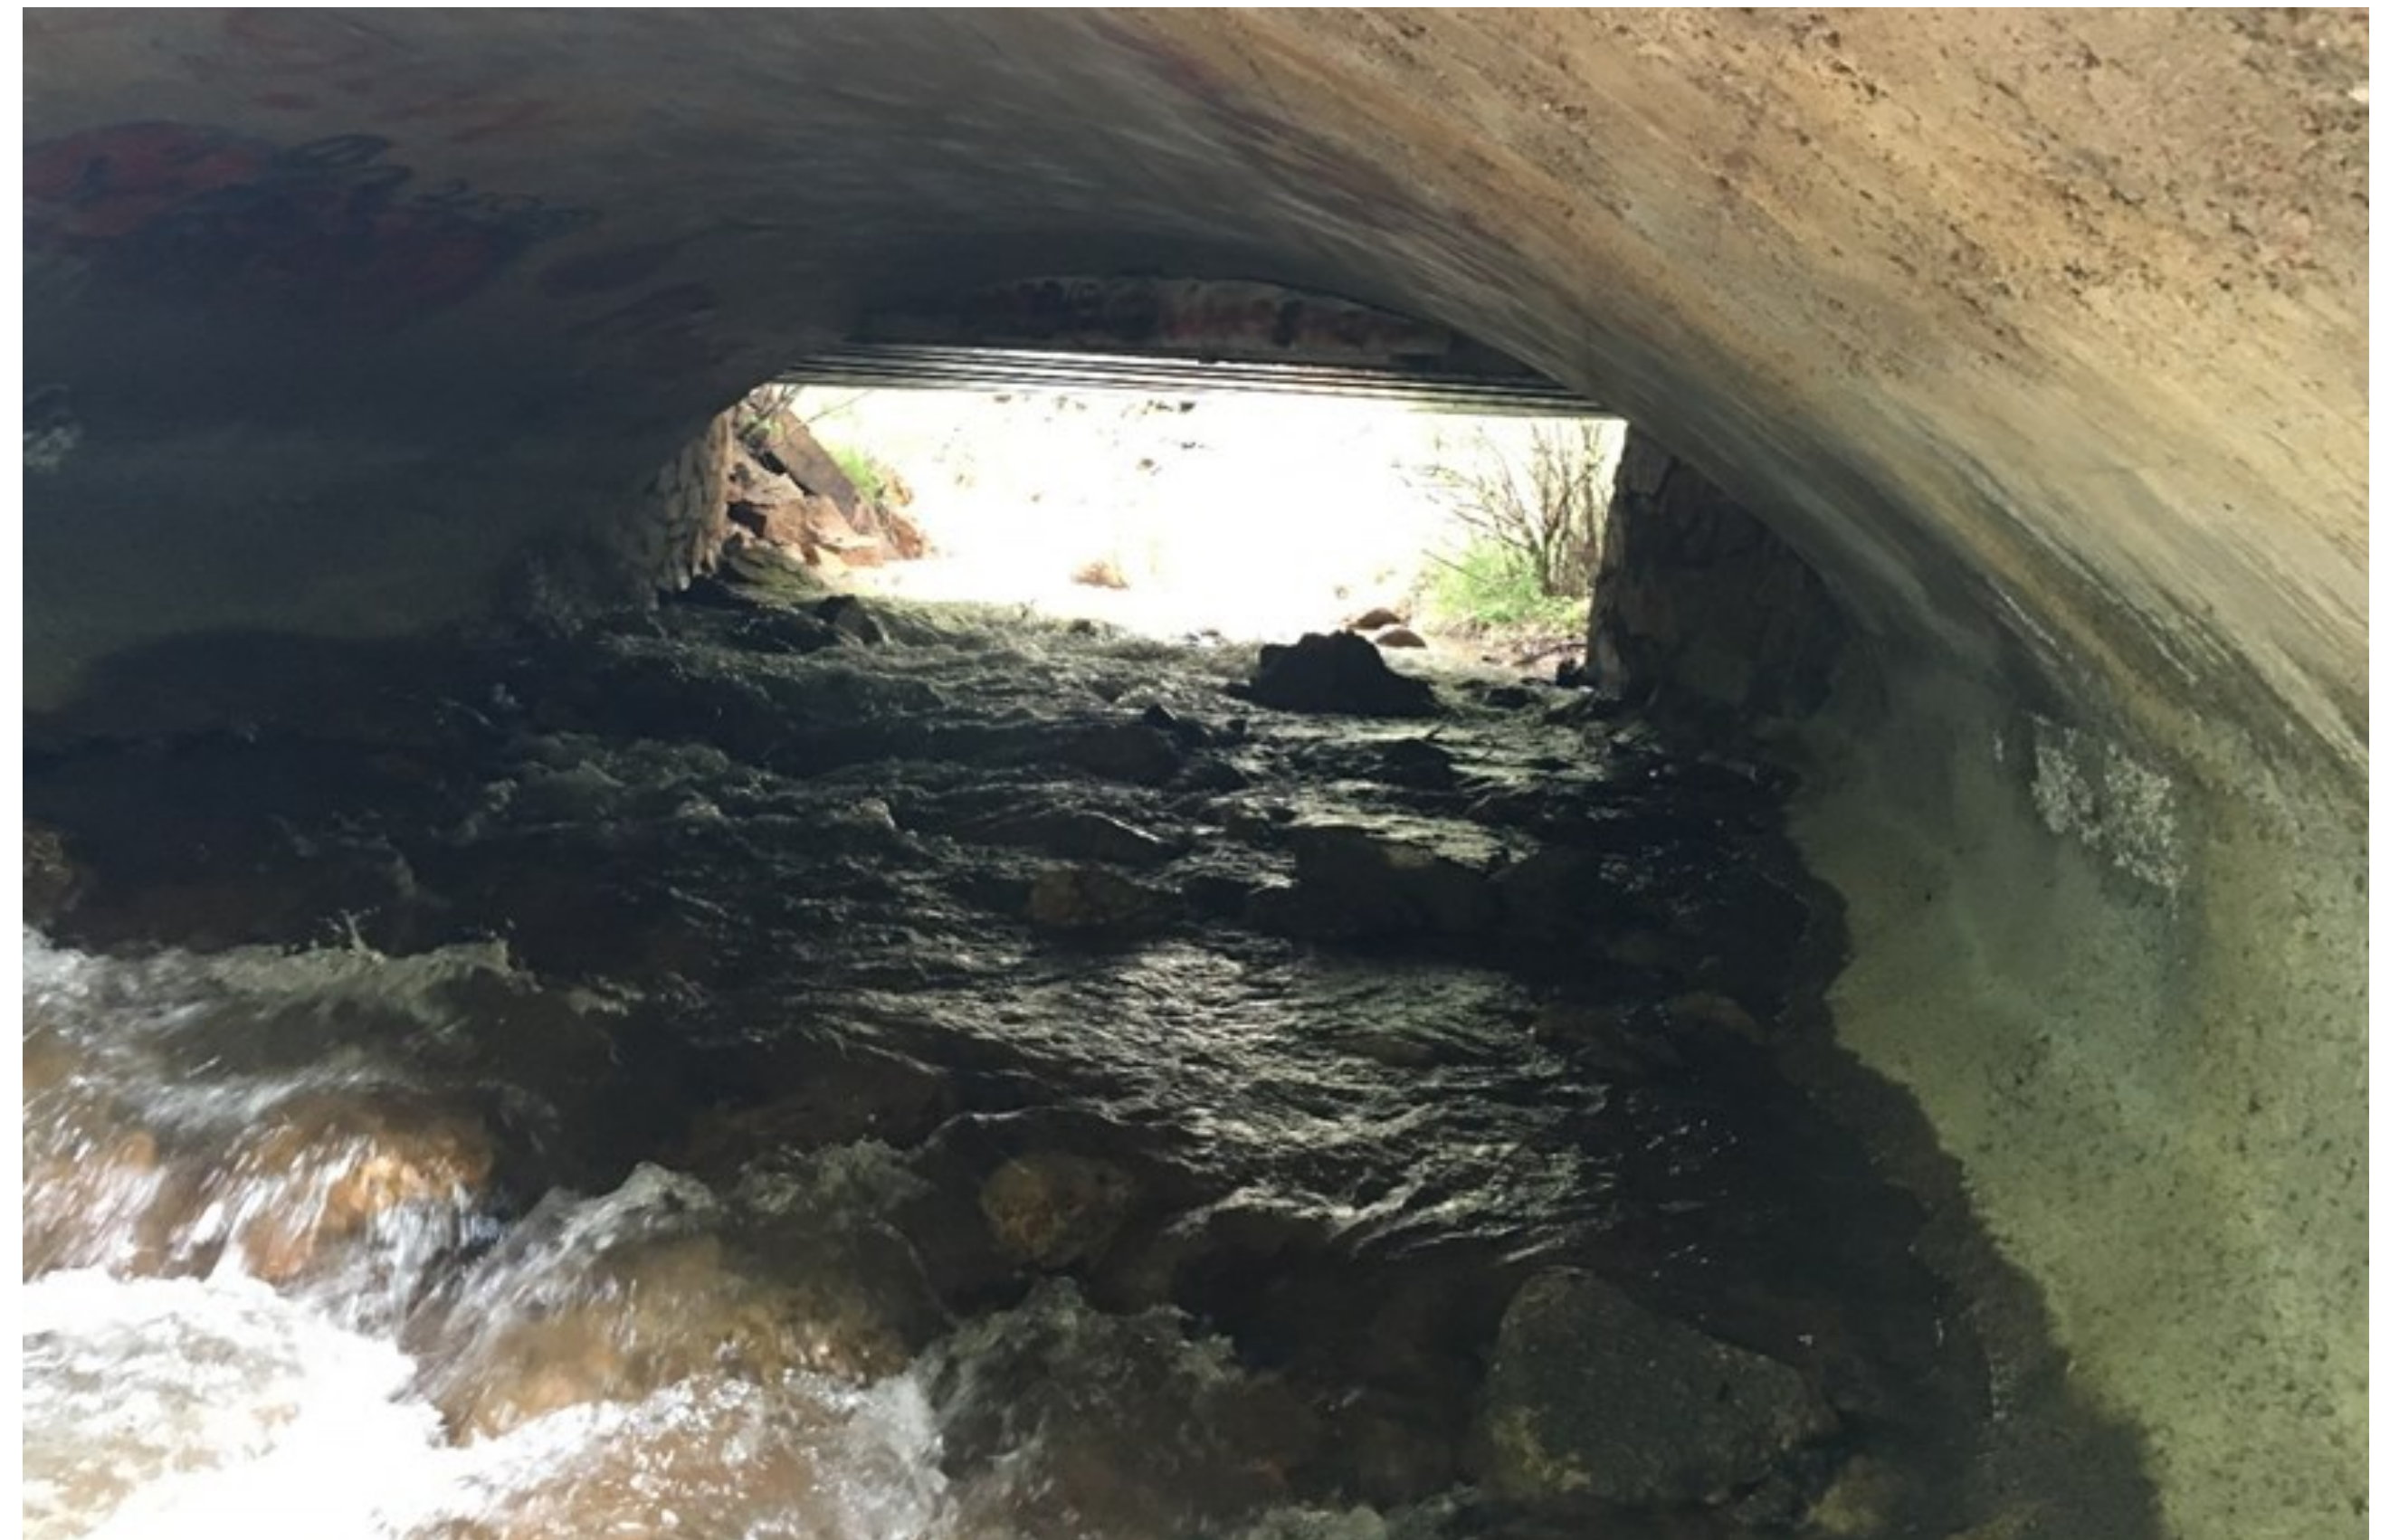
Bridge B

The bridges a composite section of two structures side by side. The original railroad rail structures were built in the 1910s, and the second structures (the stone arches) were added in the 1950s.

Existing structures are inspected on a regular basis and found to be structurally deficient.

- Degradation of the superstructure results in a load posting of 20 tons, nearly half of the standard bridge loading.
- Bridge railing is not crash rated, and heights do not adequately prevent vehicles leaving the roadway.
- Bridge approaches do not provide adequate crash protection from the guardrail end treatments.

The existing pronounced arch structures significantly reduce the hydraulic capacity of each bridge. The proposed structure will have a much larger hydraulic opening that will convey larger storm events improving future maintenance needs and improves public safety.
